Weekly Update 15

Saturday 21 January 2023

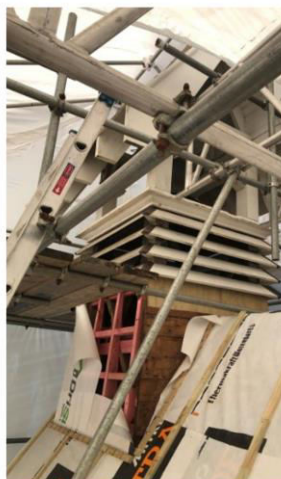
Fig. 1 Bell tower reinforcement

Above in Figure 1 you can see some of the strengthening of the bell tower, which is awaiting the building inspector’s approval before closing the building paper, fixing the battens, plywood, and finally the replacement timber shingles. The resident white-tailed spider succumbed when the old shingles were dismantled.

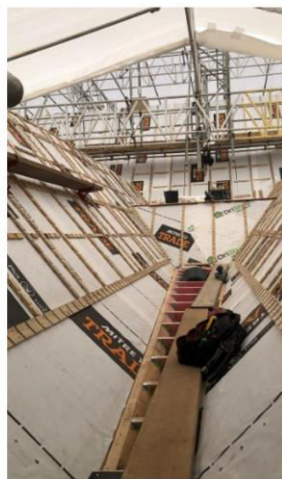
Fig. 2 East wing internal gutter

In Figure 2 you can see some of the framing for the rebuilt internal gutter. Figure 3 provides a view of the east side of the main roof from under the bell tower scaffold landing.
