Update 19

Saturday 17 March 2023

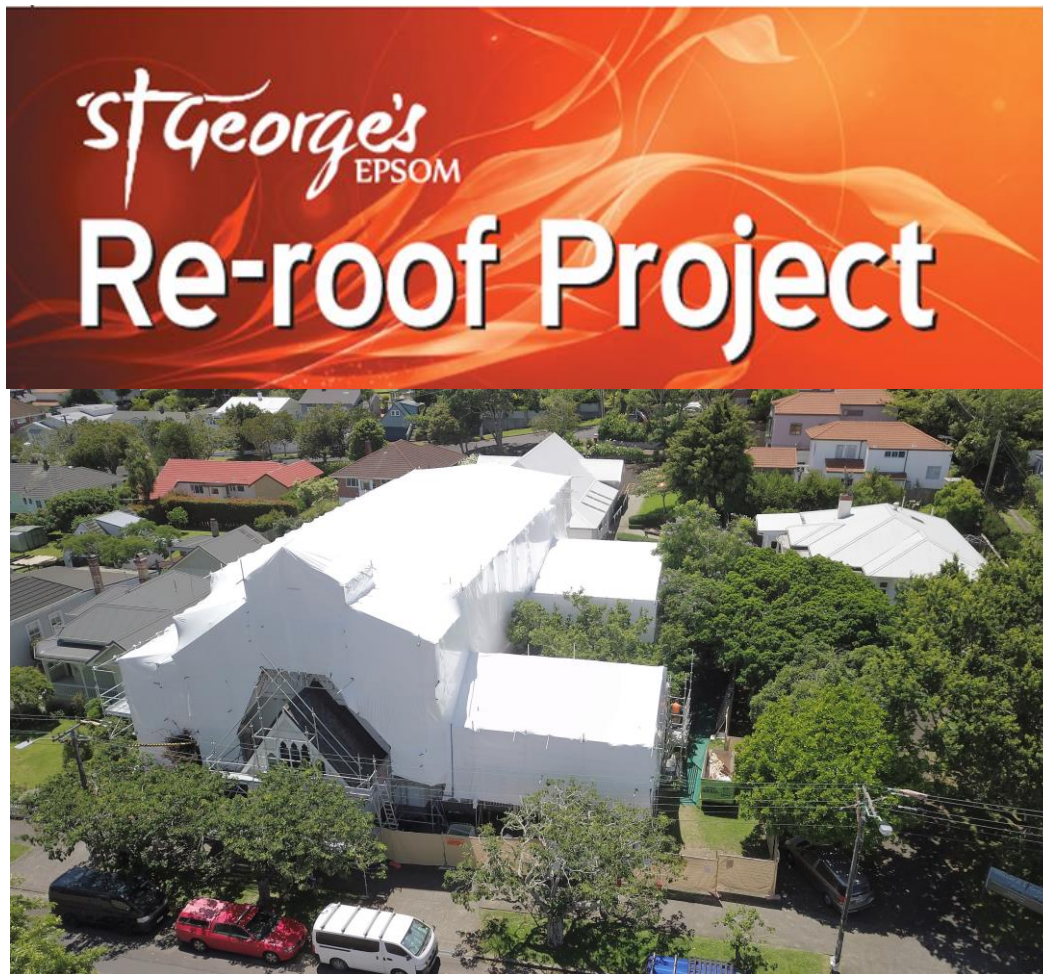
Photo courtesy of the builders across the road.

Under the covers new roof tiles are steadily covering the timber work.
